Independent Engineering Report

Aguirre Power Plant Complex

Report SL-015976.AG

September 24, 2021

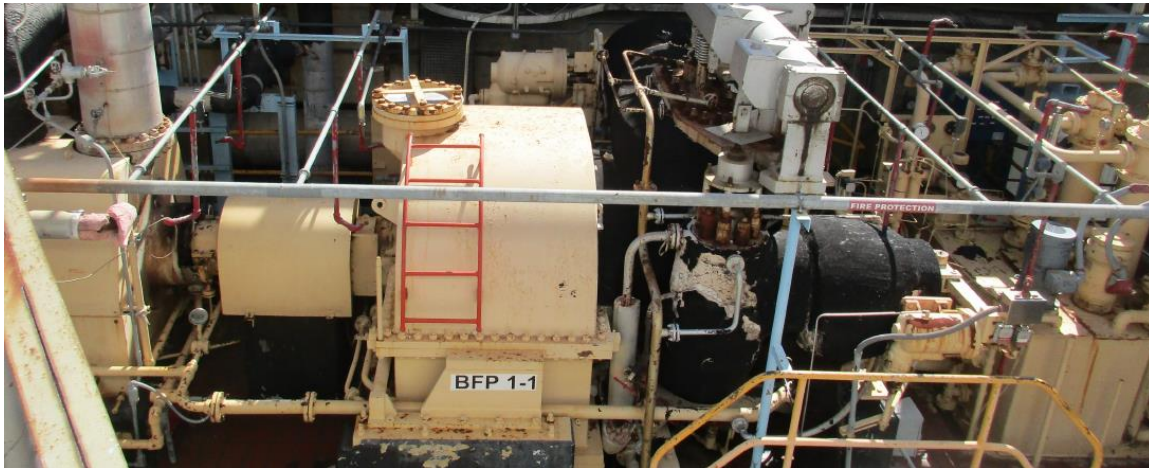
Figure 3-2 — Steam-Driven BFP, Unit 1

Steam-driven BFP is in moderate-to-good condition.

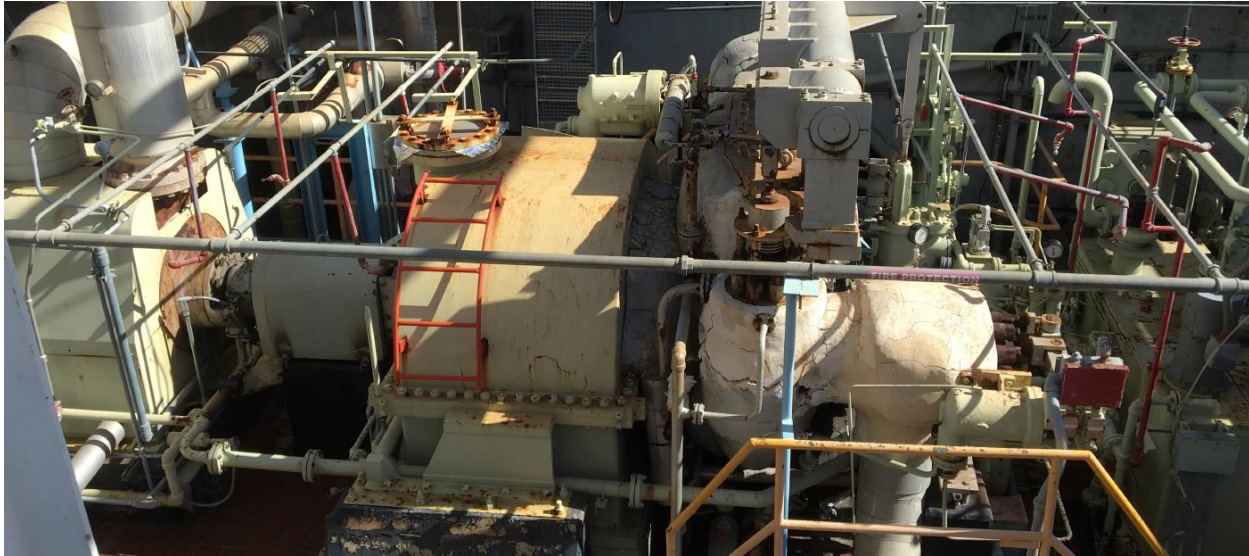
Figure 3-4 — Steam-Driven BFP Unit 2

The steam-driven BFP is in moderate condition.

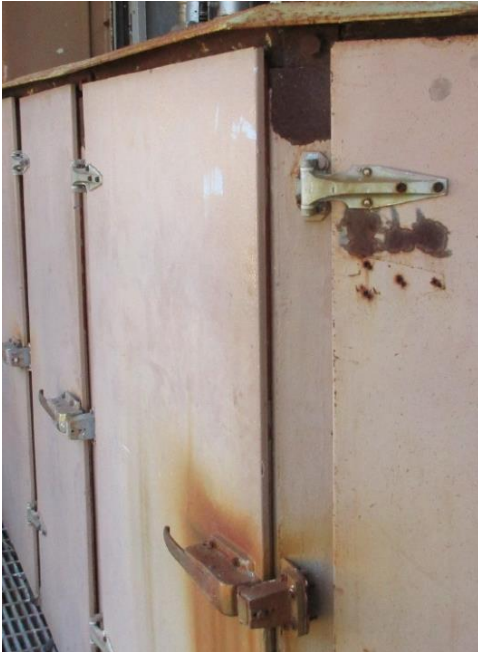
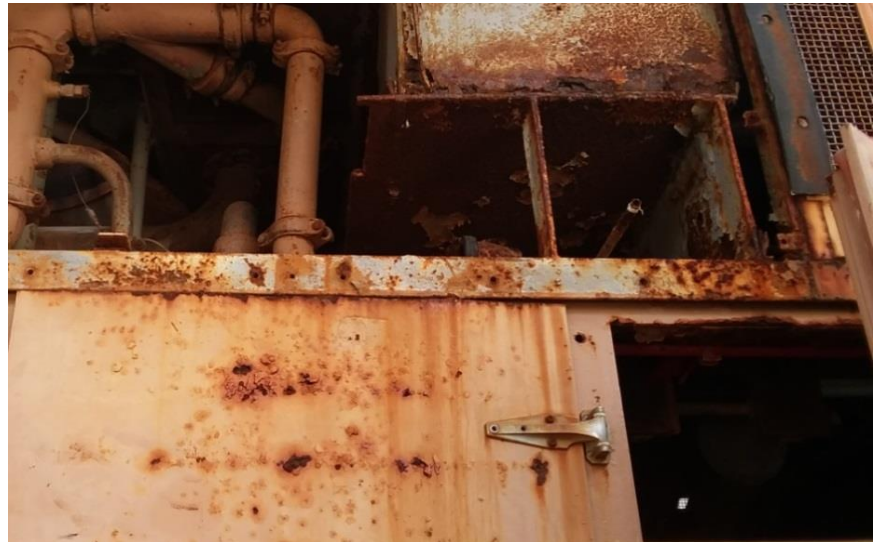
Figure 3-7 — Lack of GT Enclosure Sealing

The GT auxiliary compartment is shown above. The GT enclosures (not shown) are in better visual condition, but not all the doors seal when latched.

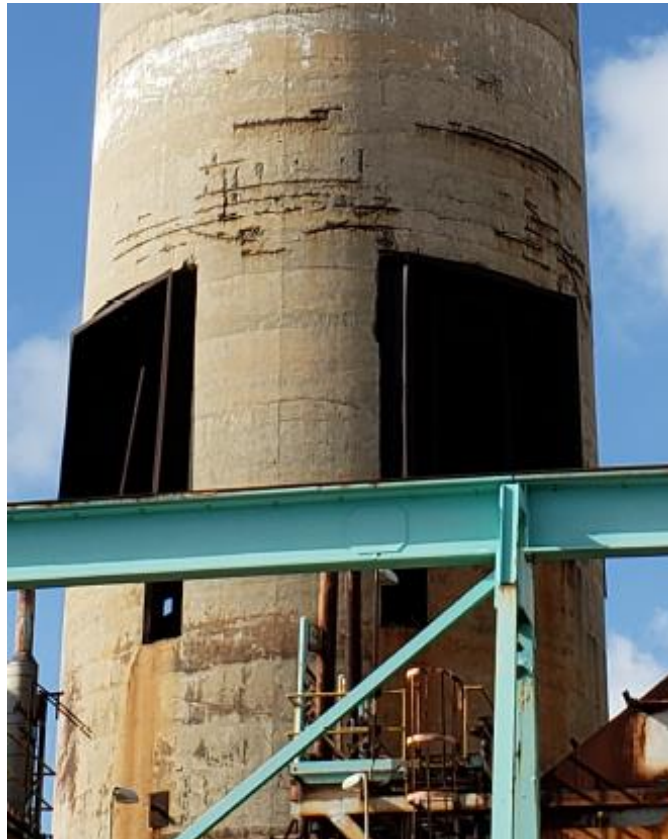
Figure 3-10 — Abandoned Concrete Stack

The deteriorating and abandoned HFO exhaust stack presents safety hazards because both spalled concrete and the structure are exposed to tropical storms and shed material. Both stacks are in a similar condition.

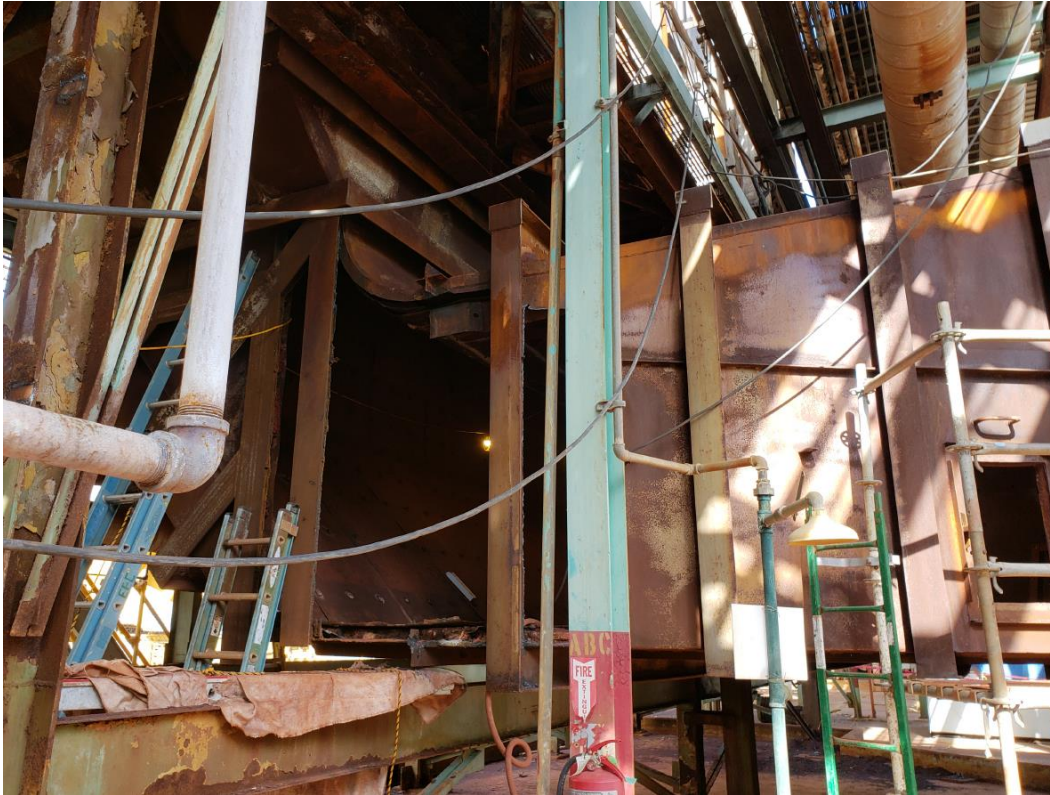
Figure 3-12 — HRSG 2-1 Inlet Duct

Seen above are HRSG inlet duct repairs addressing corrosion and leakage. Also, the flow path is being modified to improve efficiency.

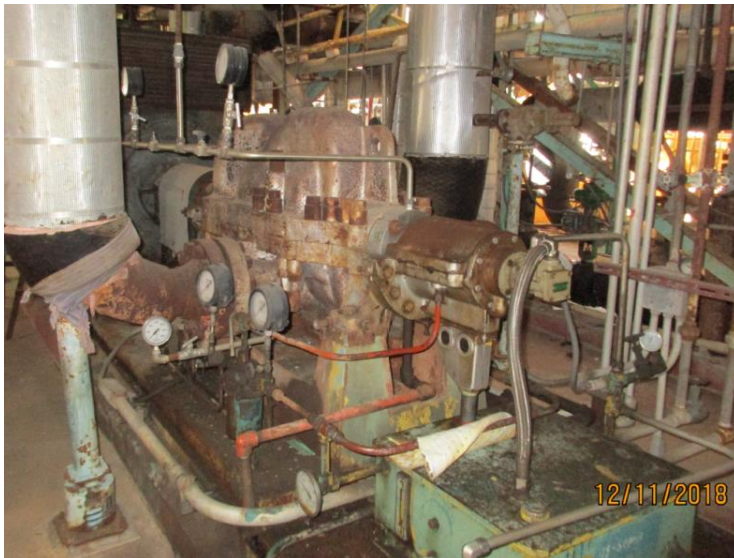
BFP 2-1. BFP 2-2 (not shown) is in a similar condition.

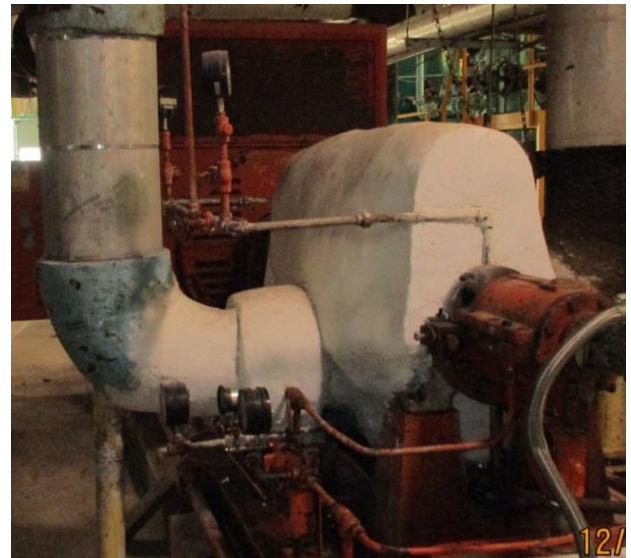
BFP 1-2 (insulated). BFP 1-1 was replaced in November 2018 with its motor rewound. The new pump is not shown. It was manufactured by Byron Jackson and will be insulated.

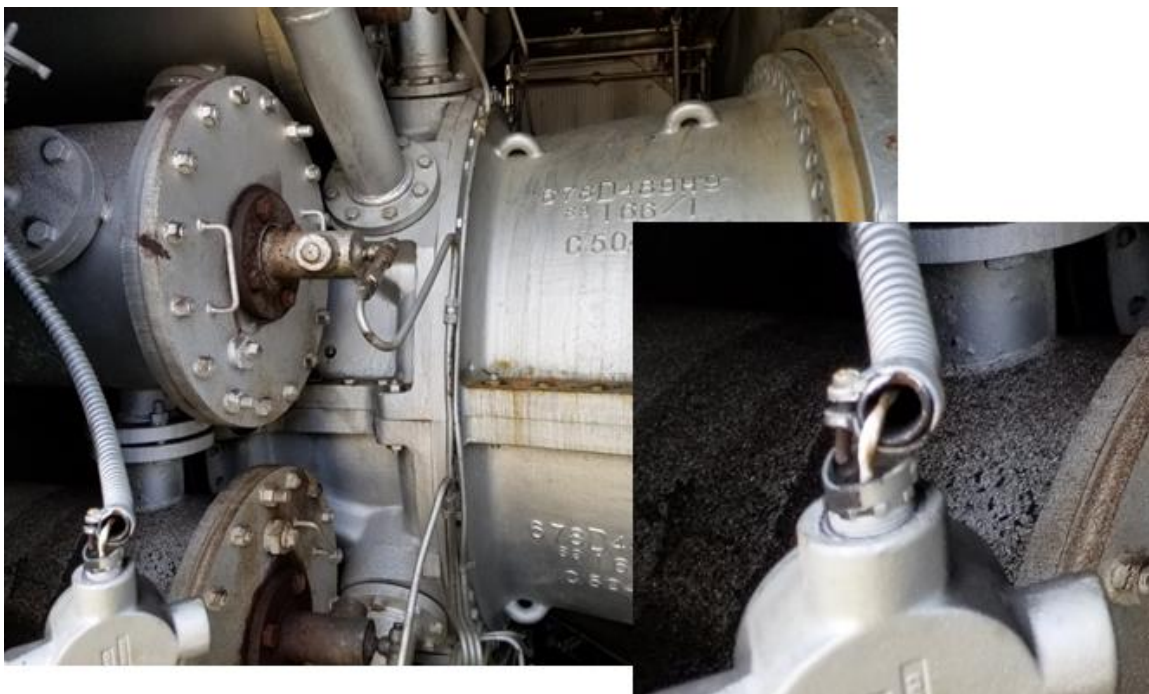
Figure 3-15 — Black-Start GT Combustor Area

The open conduit exposes wiring. There is a risk of shorting when the wire rubs and chafes against sharp metal components.

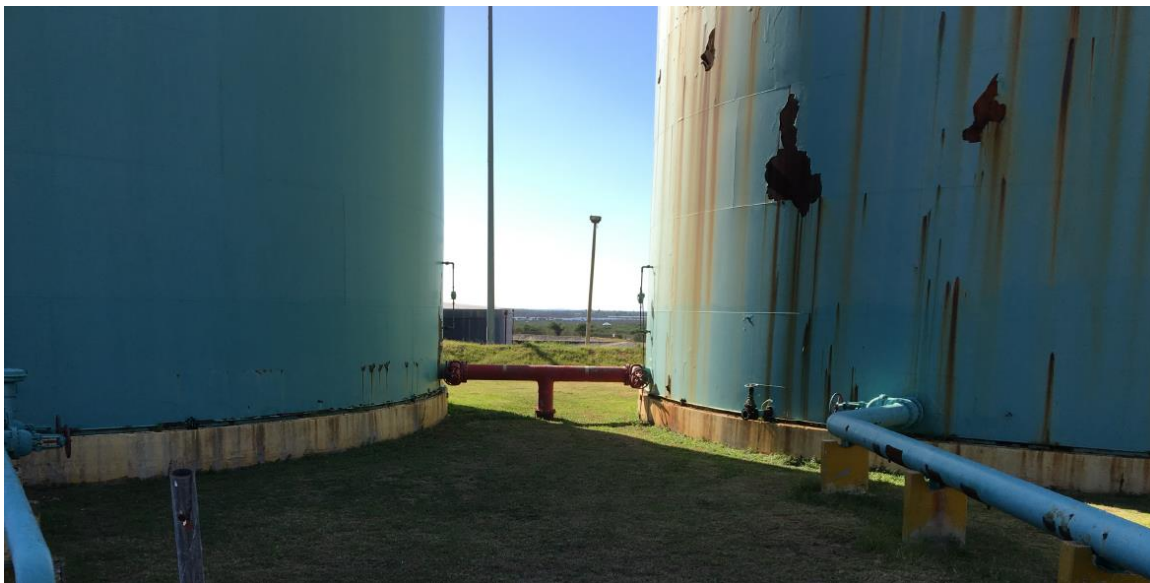
Figure 3-19 — Well Water Tanks

The two well water tanks are cross-tied and have a dedicated reserve as the fire water source. Corrosion repairs are needed on the southern tank.

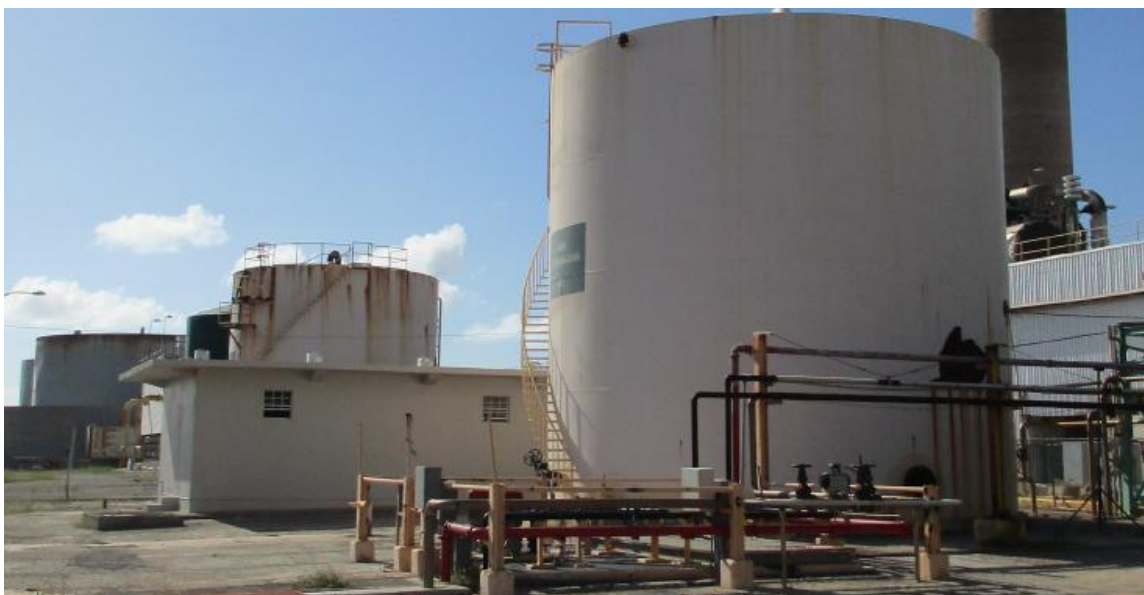
Figure 3-22 — Demineralized Water and Condensate Tanks at CC Unit

At the time of S&L's 2019 site visit, both condensate tanks at the CC unit were in service but noted to be in poor condition and approaching their end of life. As the tanks are essential to CC operation, this issue was identified as one of the top concerns for the Plant. Tank C-2 is in the worse condition of the two, along with its discharge pipe and its makeup pipe, and an RFP to refurbish its internal lining was pending at the time

Demineralized water tanks in foreground. Condensate Tank C-1 is shown on the far left (painted green).

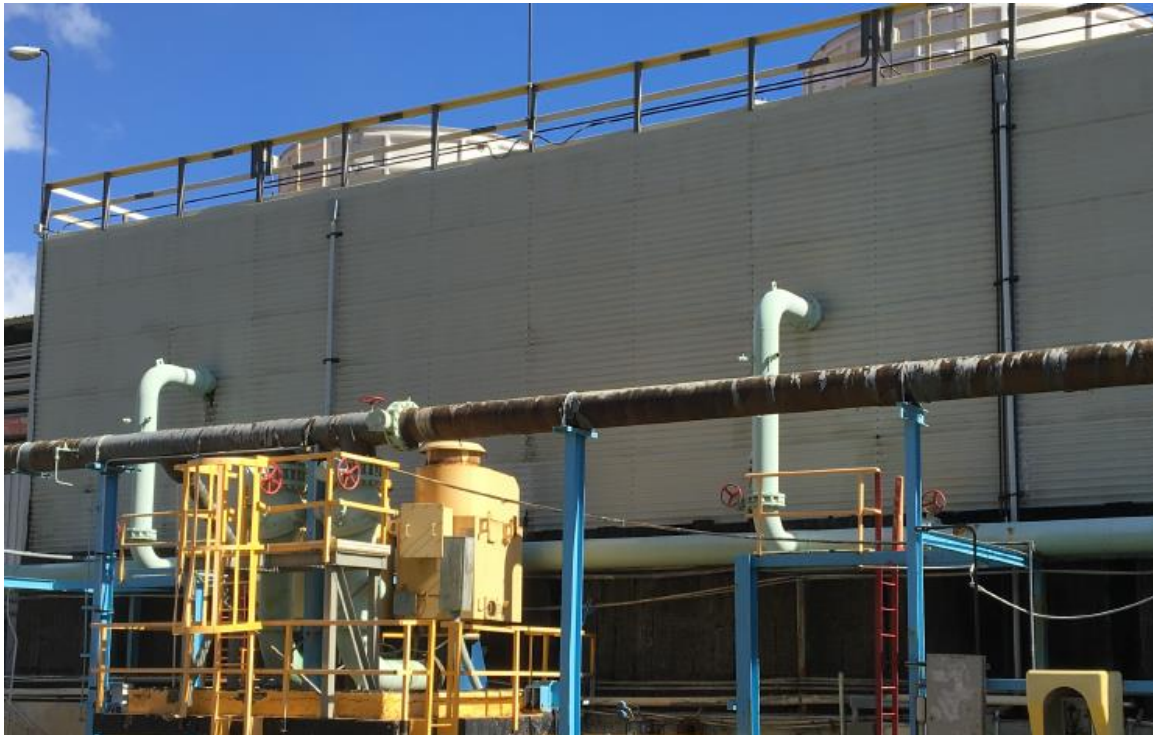
Figure 3-23 — Closed Cooling Tower, Units 1 and 2

Four-cell cooling tower for the Units 1 and 2 closed cooling water system. The two cells shown and the two closed cooling water pumps are for Unit 1. The tower extends to the right with the Unit 2 cells and pumps. The Unit 2 distribution header and risers have more corrosion than Unit 1.

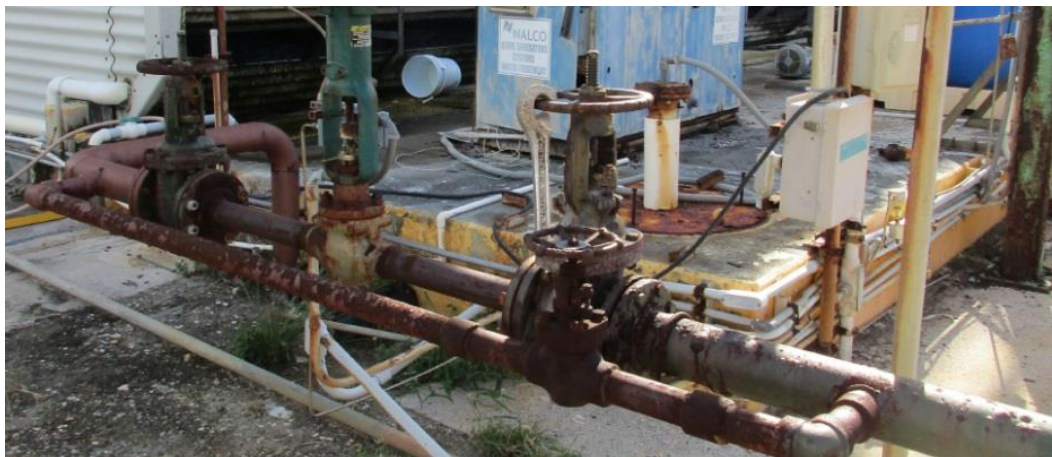
Figure 3-24 — Combined-Cycle Closed Cooling Water Tower

Makeup pumps and piping to the closed cooling tower. The ozone injection at the closed cooling tower has been abandoned in place, and the Plant plans to submit a request to have it removed.

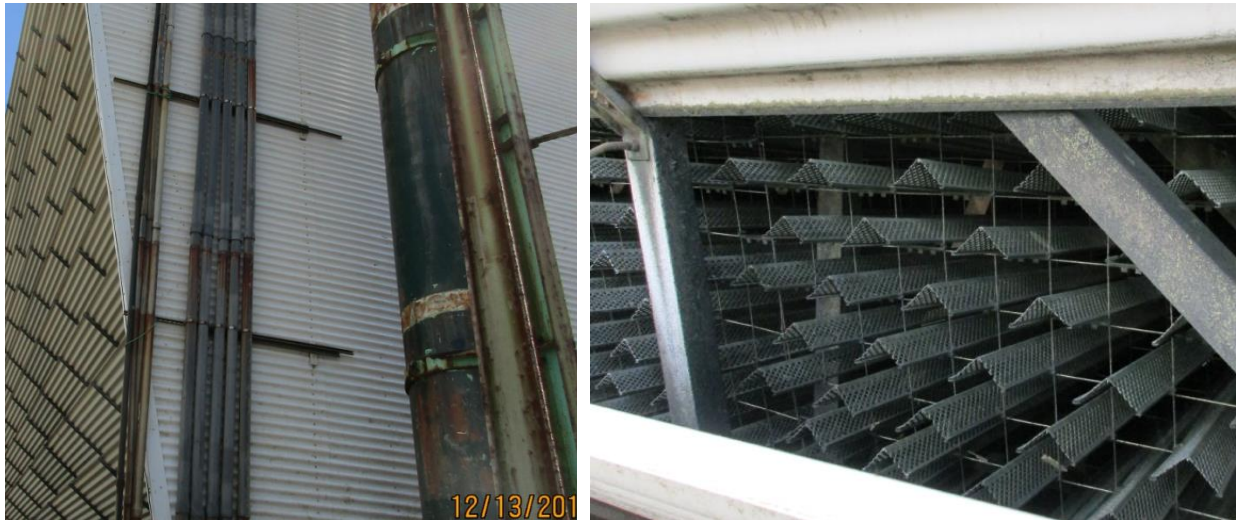
Figure 3-28 — Seawater Cooling Tower – STAG 1

One of the two circulating water risers is shown. The risers and conduits are corroded. The new fill is shown on the right.

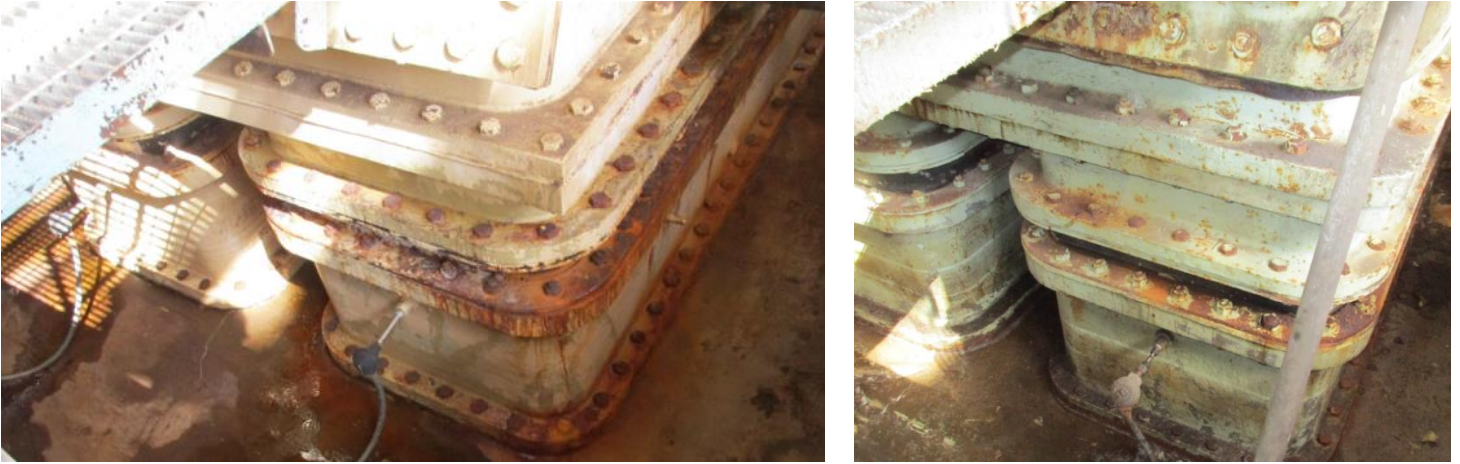
Figure 3-29 — Corrosion on Circulating Water Condenser Connections, Units 1 and 2

Unit 1 on the left, Unit 2 on the right. There is minor-to-moderate corrosion on the exterior of the flanges.

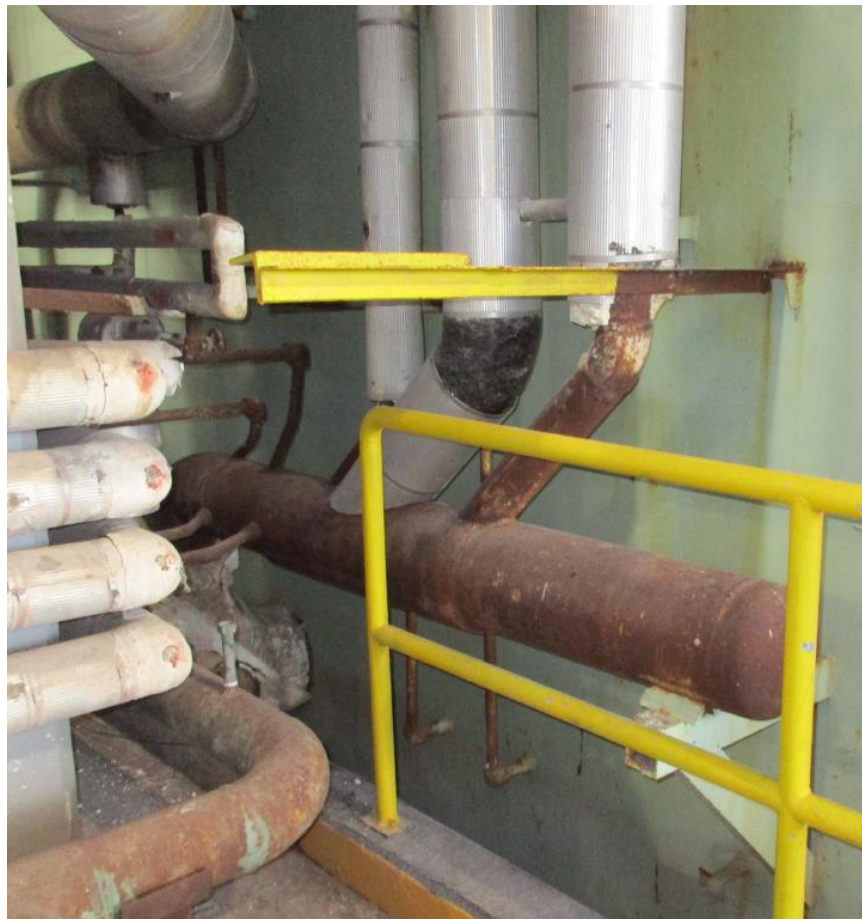
Figure 3-30 — Corroded Drain Lines into Unit 2 Condenser

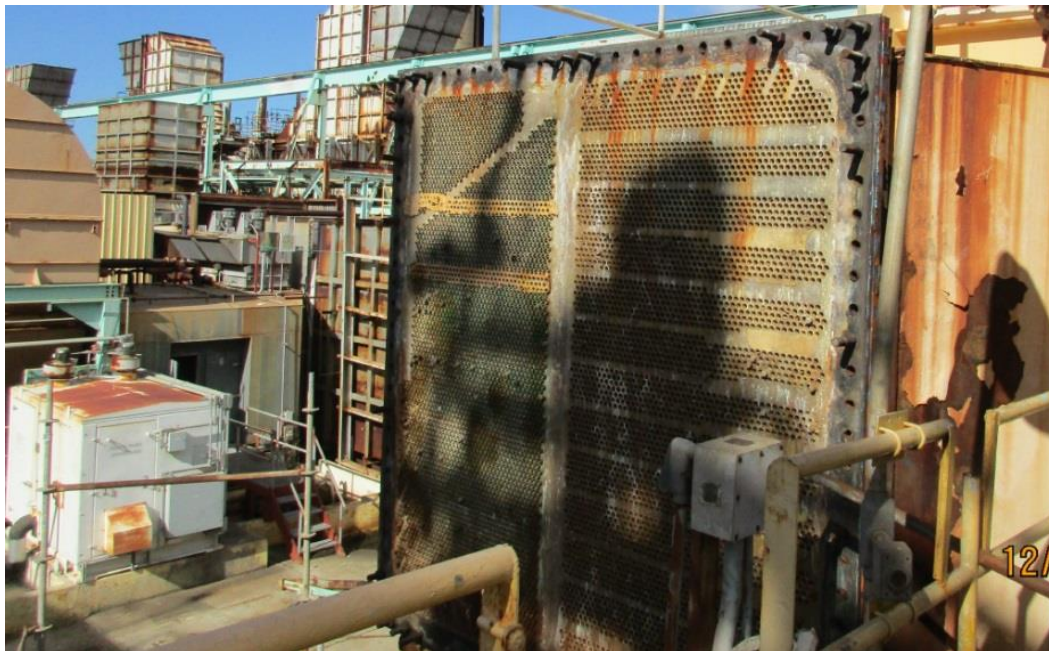
Figure 3-32 — Combined-Cycle STAG 2 Condenser

One of the STAG 2 condensers with its waterbox removed for refurbishment.

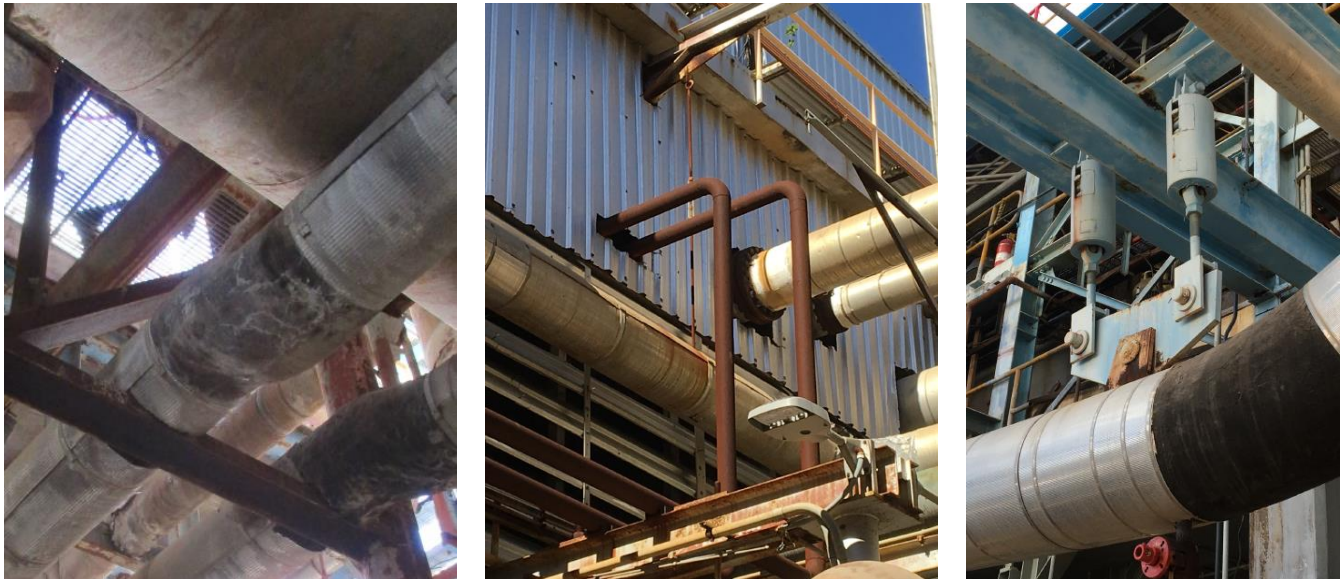
Figure 3-38 — Corroded Pipe Hangers (and Pipes), Units 1 and 2

Note that many of the steam piping hangers were in good-to-moderate condition, as seen in the far-right photo.

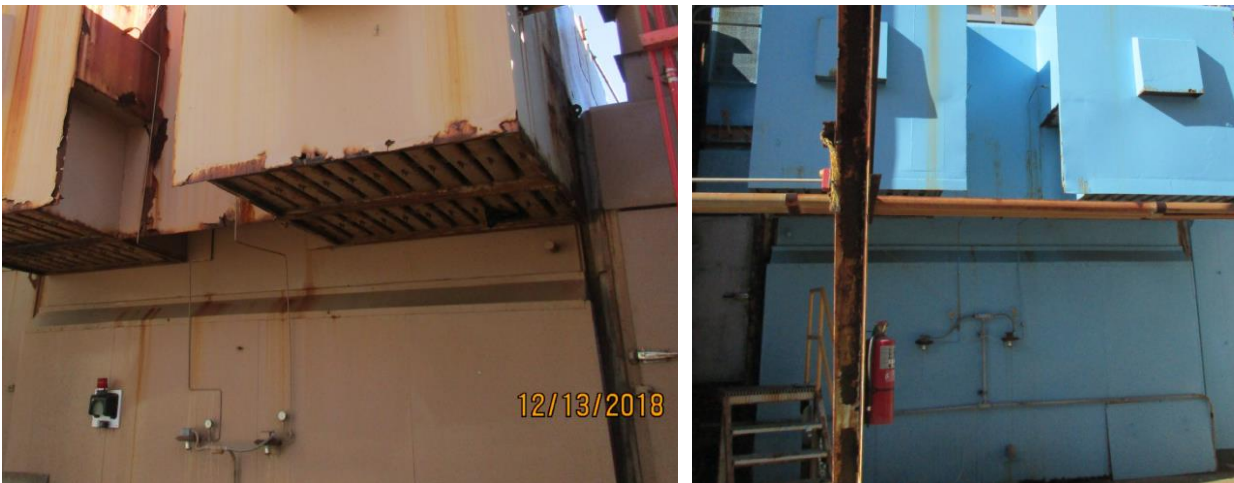
Figure 3-39 — Refurbishment of GT Generator Filter Cabinets

Original in brown (scheduled for refurbishment); refurbished in blue.

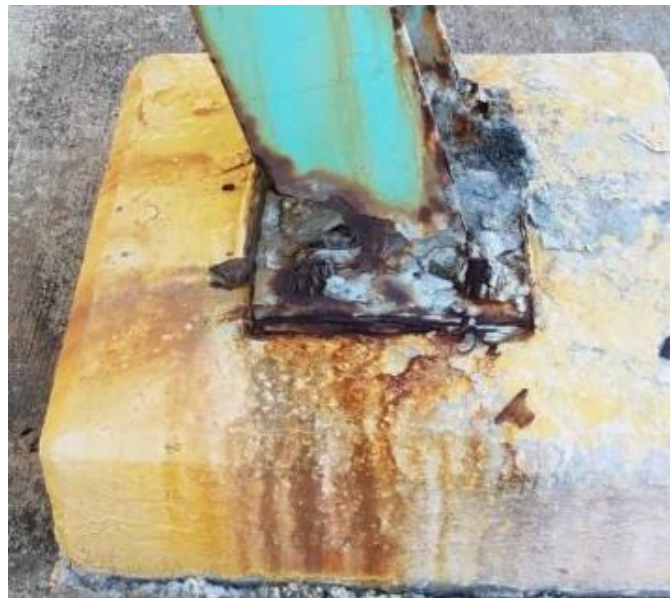
Figure 3-40 — Corrosion of Gantry Crane Structural Steel at Combined-Cycle Plant
